TS-50 Button Repair and SMD Elko Exchange

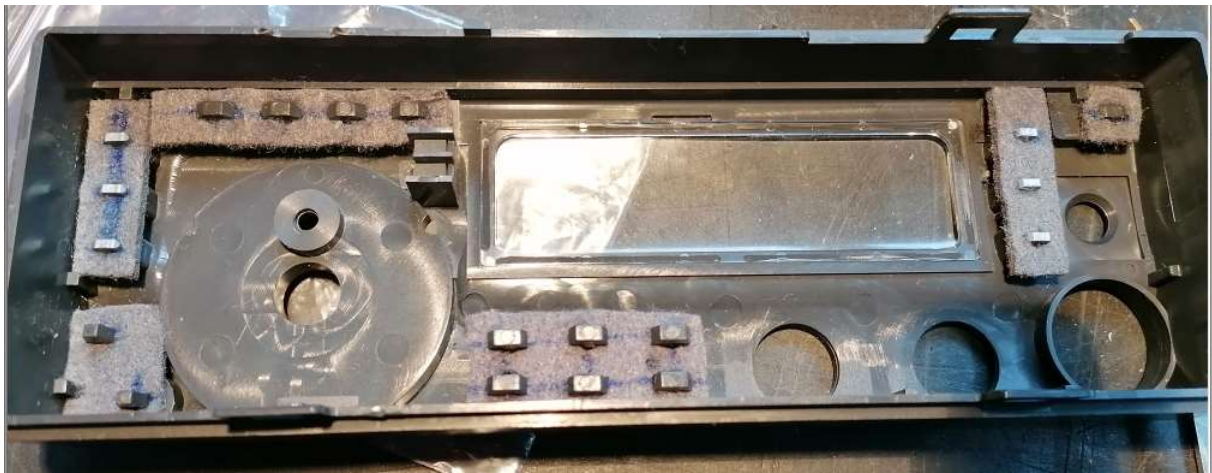
Front Panel Buttons Repair

Behind the plastic front panel Kenwood used some foam to hold the little buttons from falling out. This foam was decomposed and fall out during cleaning. After thinking how I can fix those little buttons, I had the idea to fix them with pieces of non-woven material with about 1mm thickness. First I tried it with 2mm material (on the photo) , but that was too thick. I cut the relevant pieces and punched 2.5 mm holes with some special hole pliers (for waistbelts) .

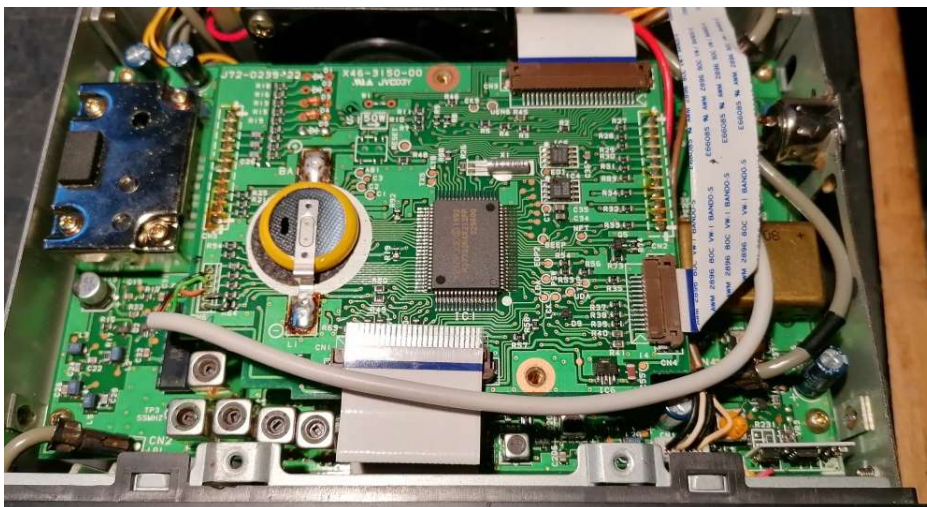
Battery exchange

When the transceiver was open, it was easy to find the 3V backup battery under the bottom cover. I inserted a new special CR2032 with solder lugs. Just be careful not to produce any shorts and insert it in right polarity.

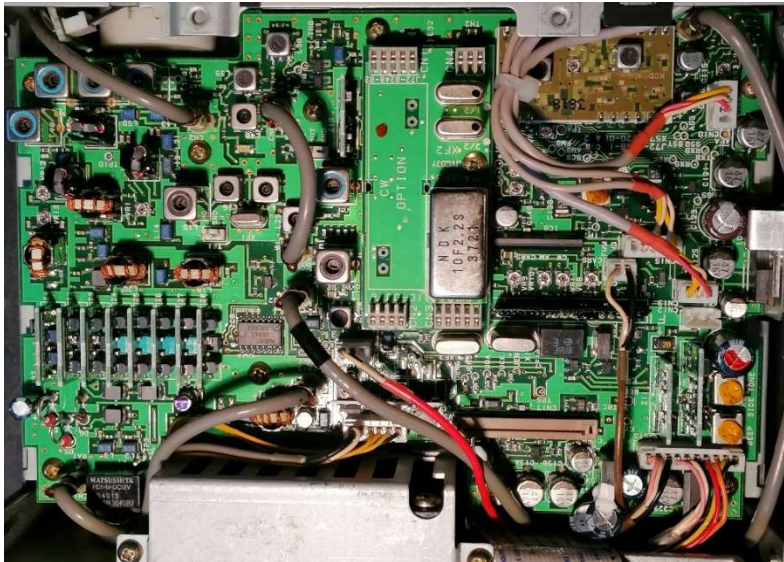
The TS-50 has quite some of those surface mount Capacitors, which leak acid liquid after years. This liquid may destroy the pads on the pcb and the capacitors do not work reliable any more. So after 20 years its time to exchange them, before they destroy your board. In my case the radio did still work without failures. Those capacitors are on 3 different boards:

As you see its quite tight on that board. For your work you should mark and remove all connectors from the TRX Board and deassable it. To remove the surface mount capacitors I hardly advice to use 2 solder irons with a round tip or solder scissors otherwise you will destroy the board. Clean the board underneath the capacitors be soldering the new ones.

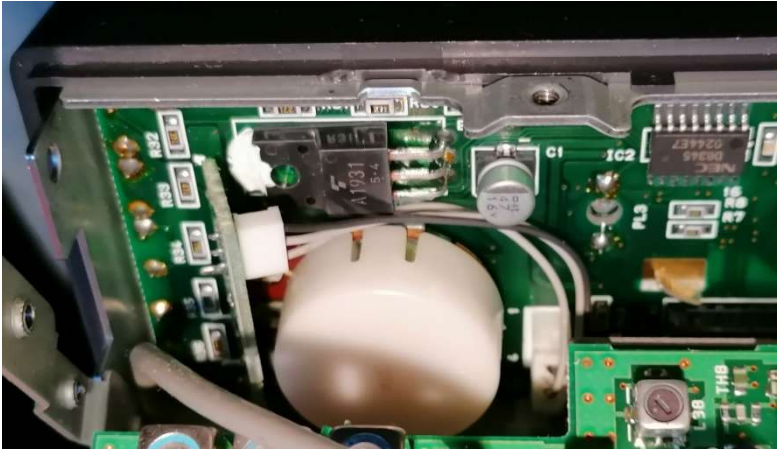
PLL Board

The PLL board and the Display board do not need to be deassabled.

Just be careful with the 3 wires close to the capacitor with your solder iron.
